DECAY STUDIES IN WOODEN BOATS AND SHIPS

**DIVISION OF FOREST PATHOLOGY
U. S. DEPARTMENT OF AGRICULTURE
WASHINGTON 25, D. C.**

**BUREAU OF SHIPS
NAVY DEPARTMENT
WASHINGTON 25, D. C.**

12 DECEMBER 1953

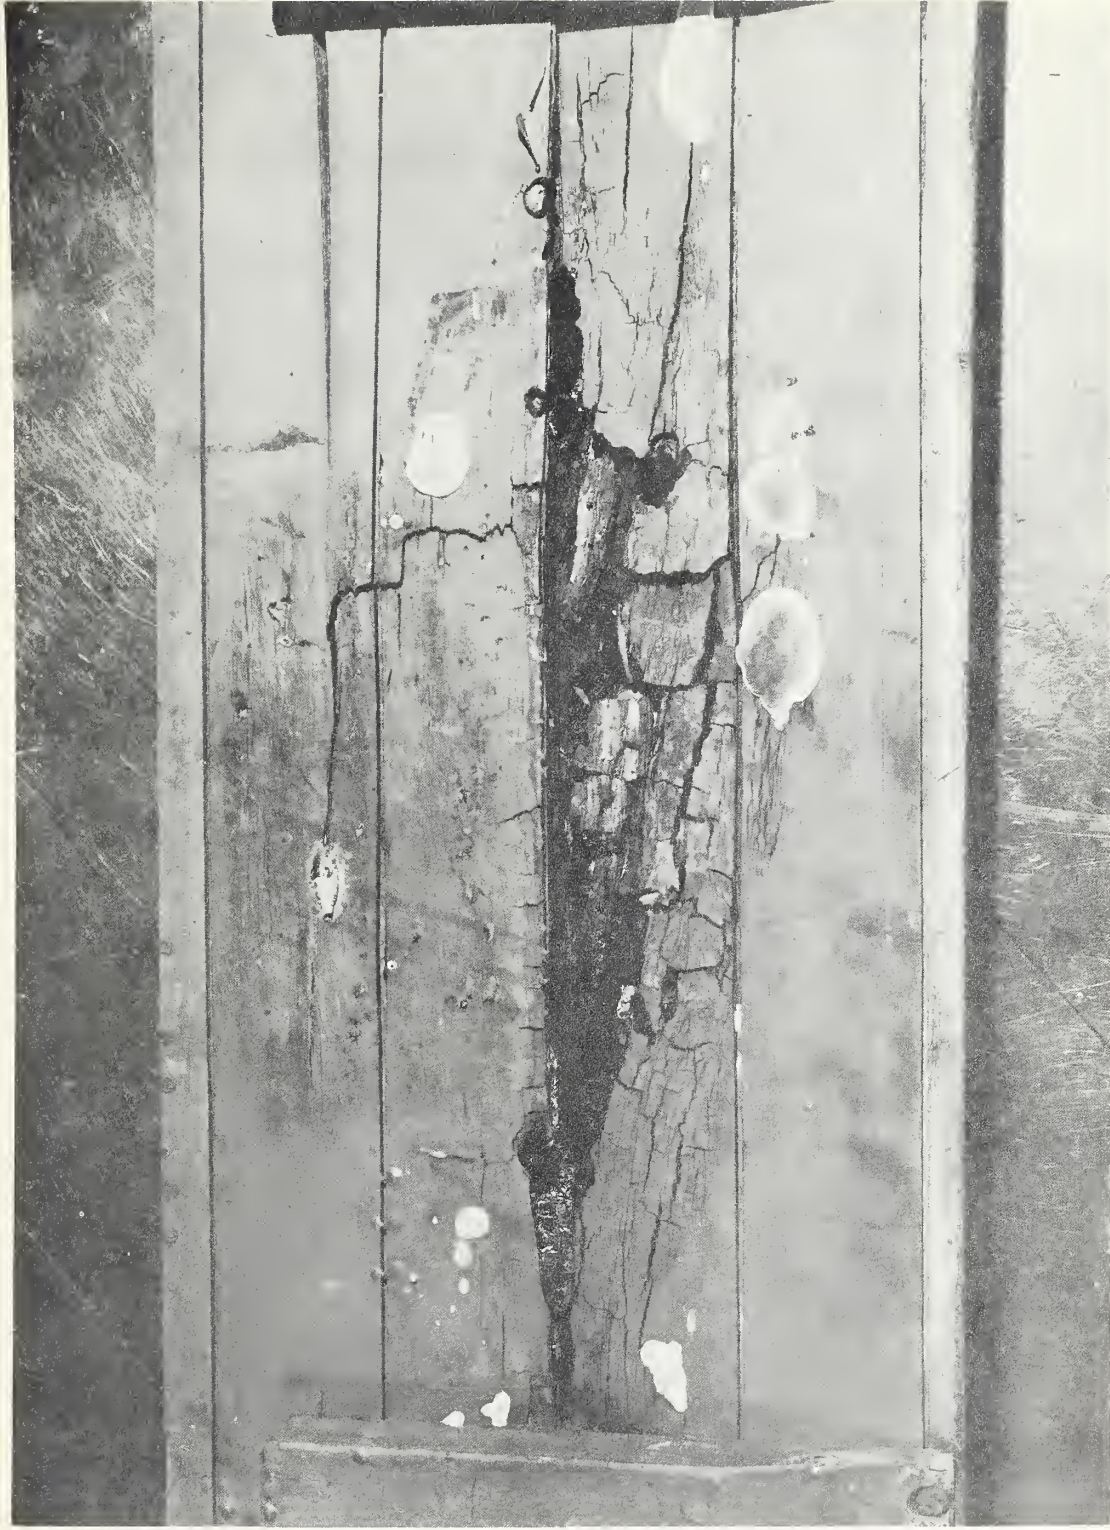
In wooden hulls nearly all the deterioration that is not clearly mechanical or caused by borers is due to a group of specialized fungi. More than twenty different species of this group have been found growing in ship timbers (ref. j). The microscopic threads of the fungi grow through the wood and make it brash and low in shock resistance even before there is perceptible softening or visual sign of decay. However, brashness does not necessarily mean infection. If a piece is uniformly weak throughout, it usually means that the wood was weak to start with. Fruiting bodies are sometimes formed on the surface of the wood, which produce multitudes of the microscopic wind-carried spores that start new infections. One type of fruiting body is shown in Fig. 1.

Fig. 1. Decay in ash locker cover, showing the spore-producing mats of the decay fungus.

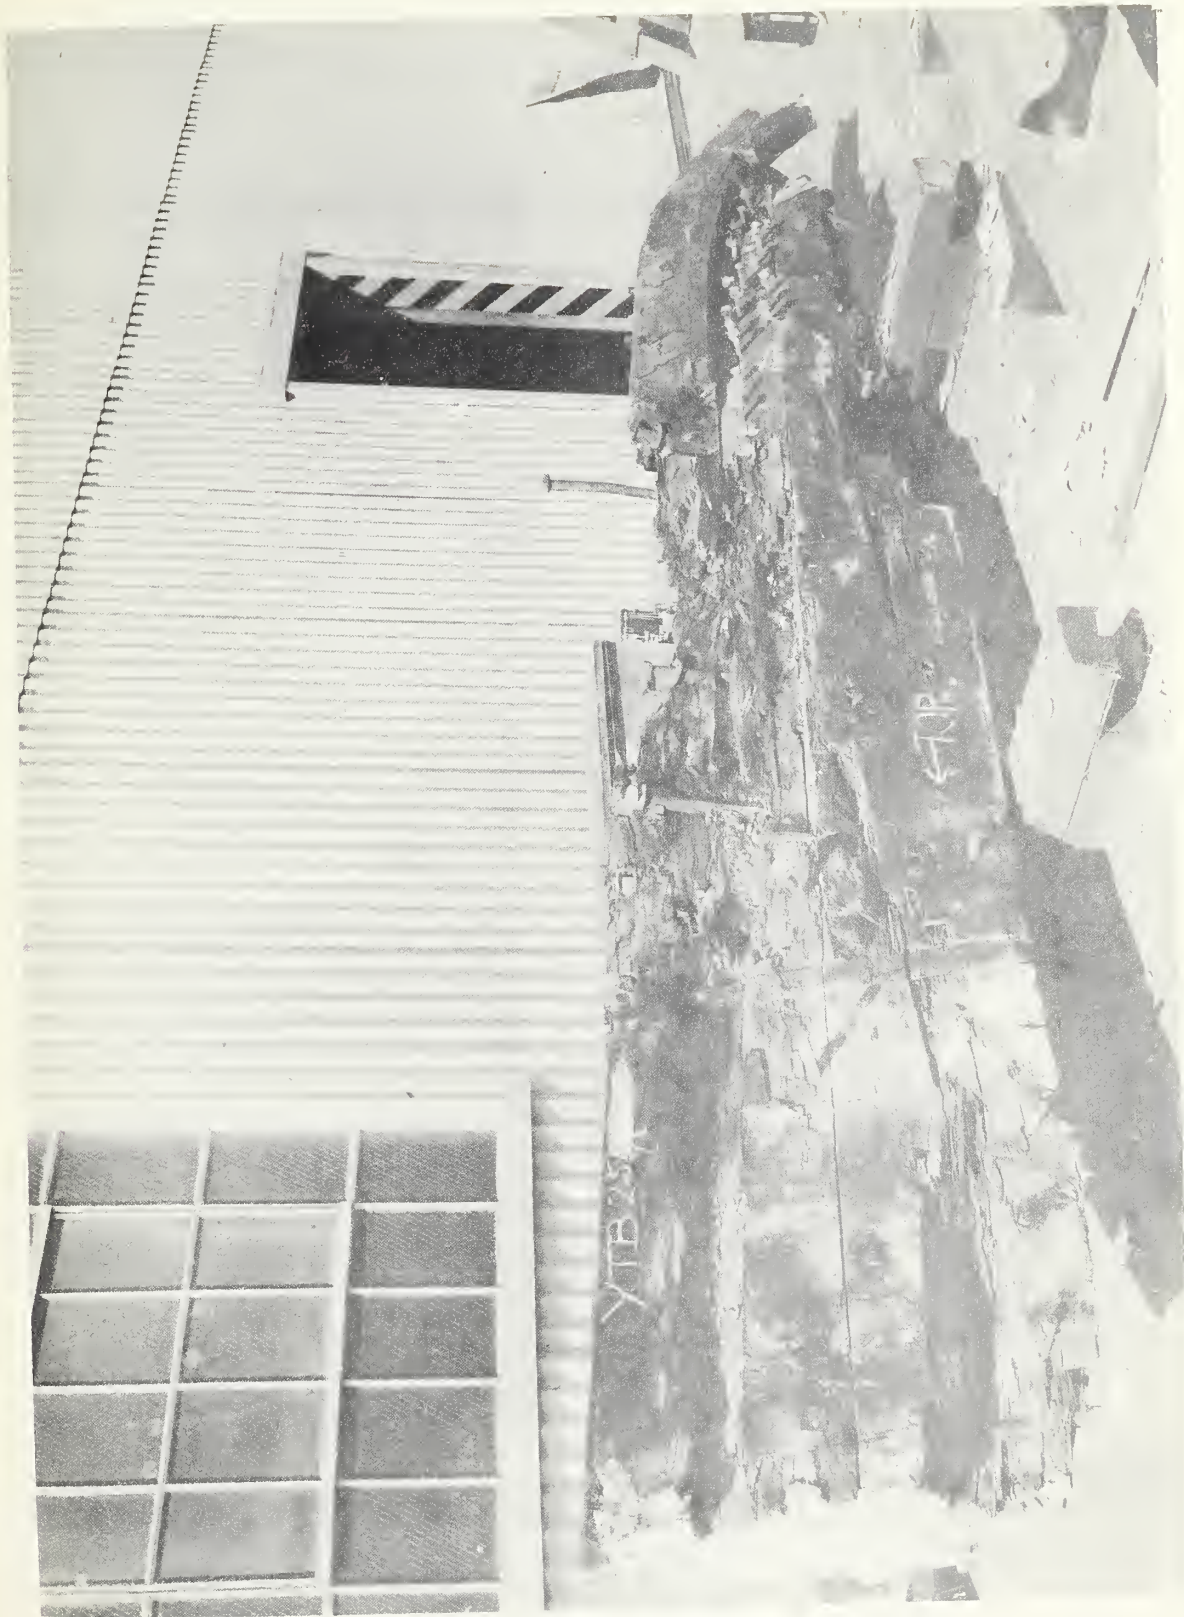
In hulls built during World War II, there has been opportunity to examine four ships of the APC type, four PCS, two YTB (Figs. 2, 3), four YTL, one YAG, one TAKL, and four YMS, all 8 to 9 years old, and two MSB at the age of 6 years (Fig. 4) as well as three YP of unknown age. Of the tugs, the two YTB and three of the YTL were severely decayed, one in the bow (Fig. 2), one in both bow and stern, and the others so extensively decayed throughout as to cause their condemnation. Even in ships condemned because of decay, the major portion of the wood is still sound. Decay in a small proportion of the framing members may involve such heavy labor costs in replacements as to require survey. Repair costs due to decay in the least infected of the five, a 110-foot YTB, were reported to have averaged \$10,000 per year of life, in addition to the service time lost during repeated repairs, and still not all of the obviously decayed wood has been removed. The fourth YTL, though in essentially fresh water service, showed no decay in the superficial examination which was all that could be made. The APC hulls showed much decay in forward bulwark stanchions and frameheads, knightheads and stems. In the types with frames hidden by ceiling, removal of the ceiling would undoubtedly have disclosed more decay than was seen. More details as to the decay of most of these ships were presented in references a and b.

Fig. 2. Decay in stem and apron removed from MENATONEN, YTB 254.

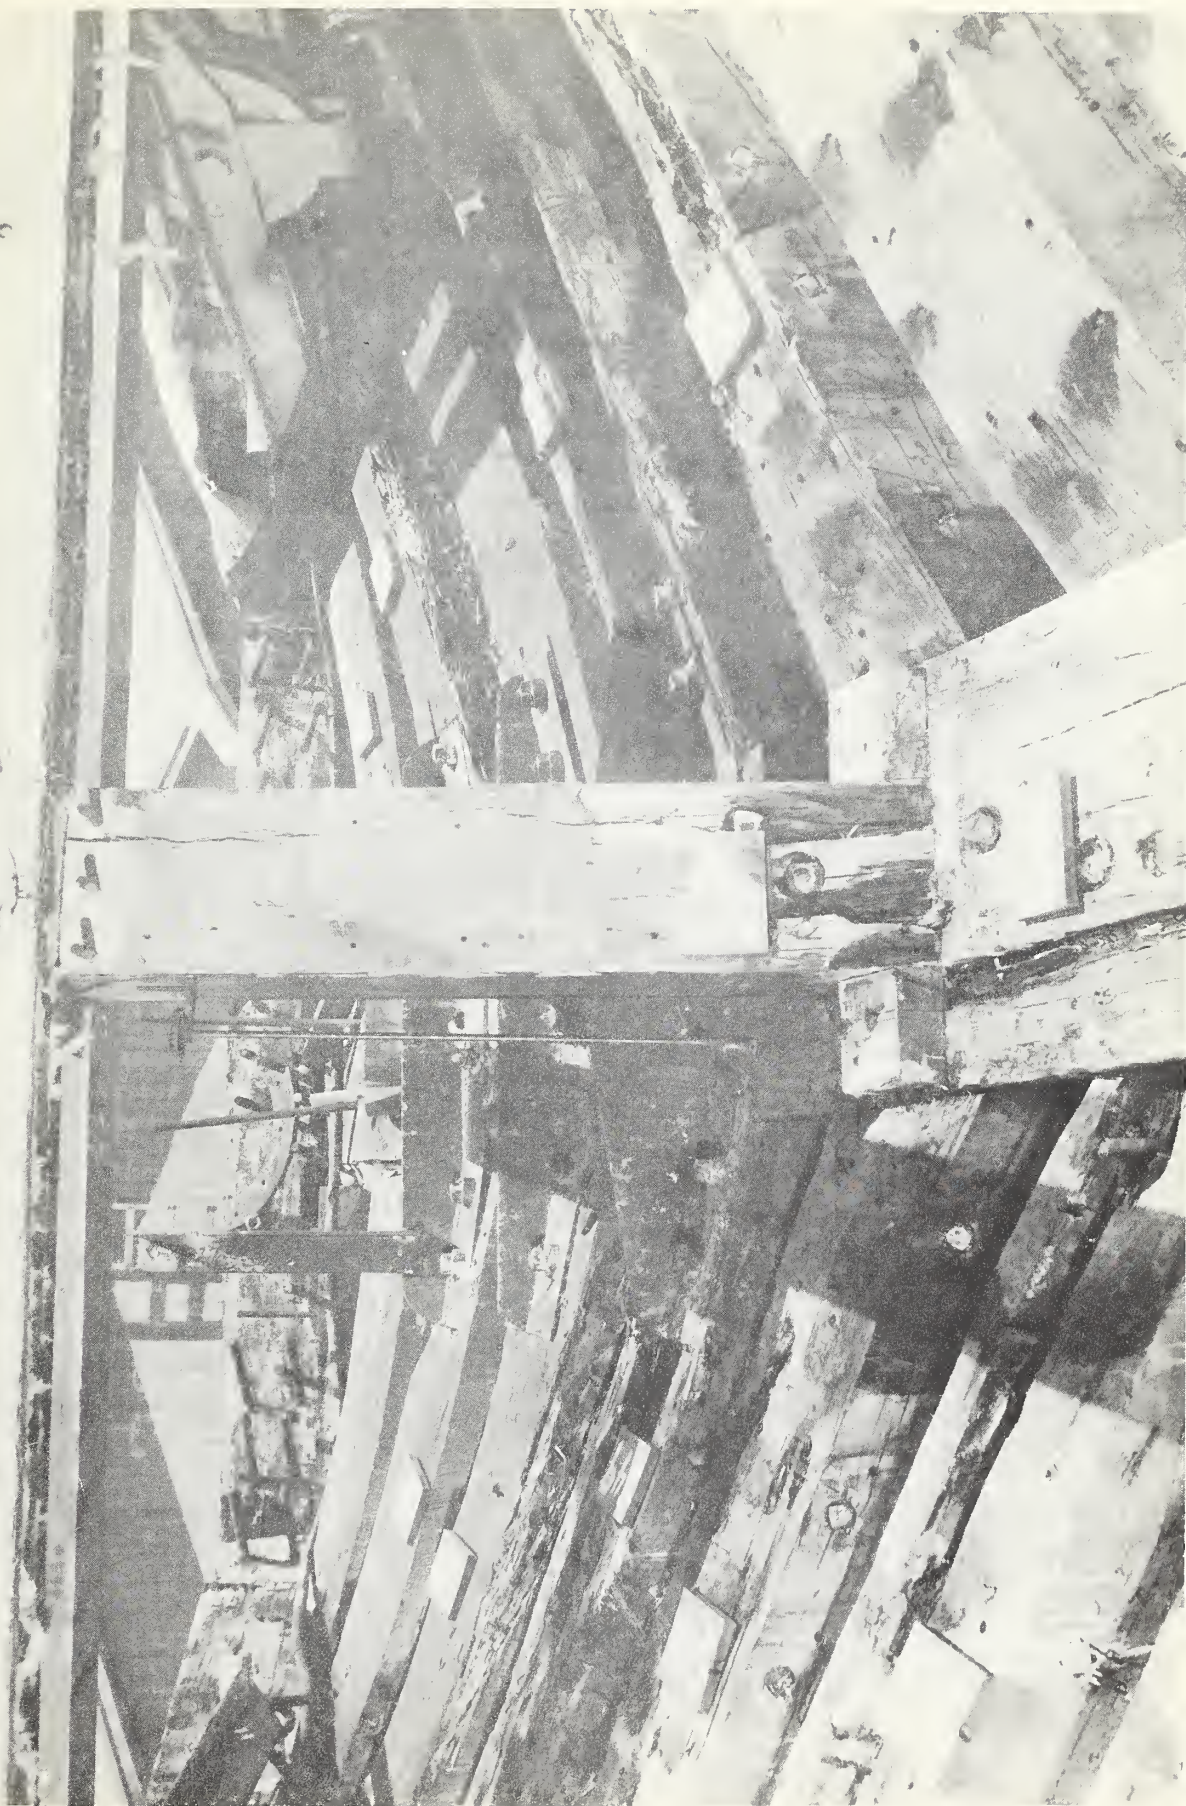
Fig. 3. View aft in YTB 224, nine years after construction. Decay in nearly all of the frames.

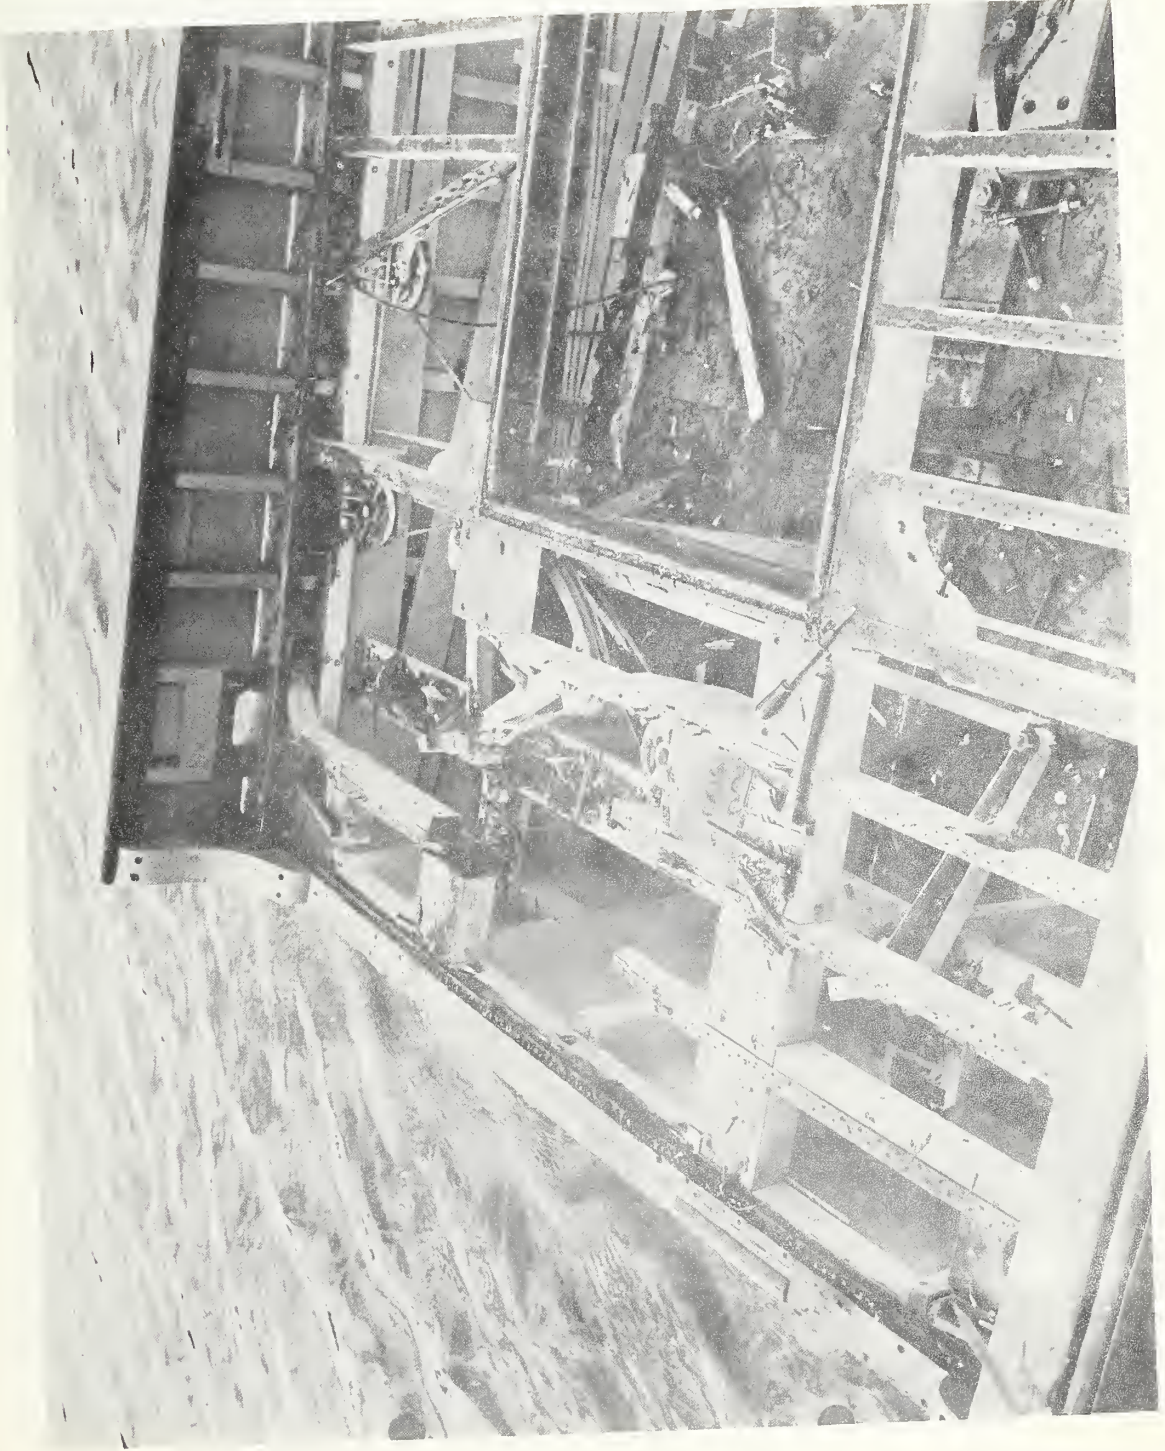
Fig. 4. Repairs required in unventilated lazarette of MSB-1, due to decay after six years in service. Present design fortunately does not include bulwark stanchions through the planksheer.

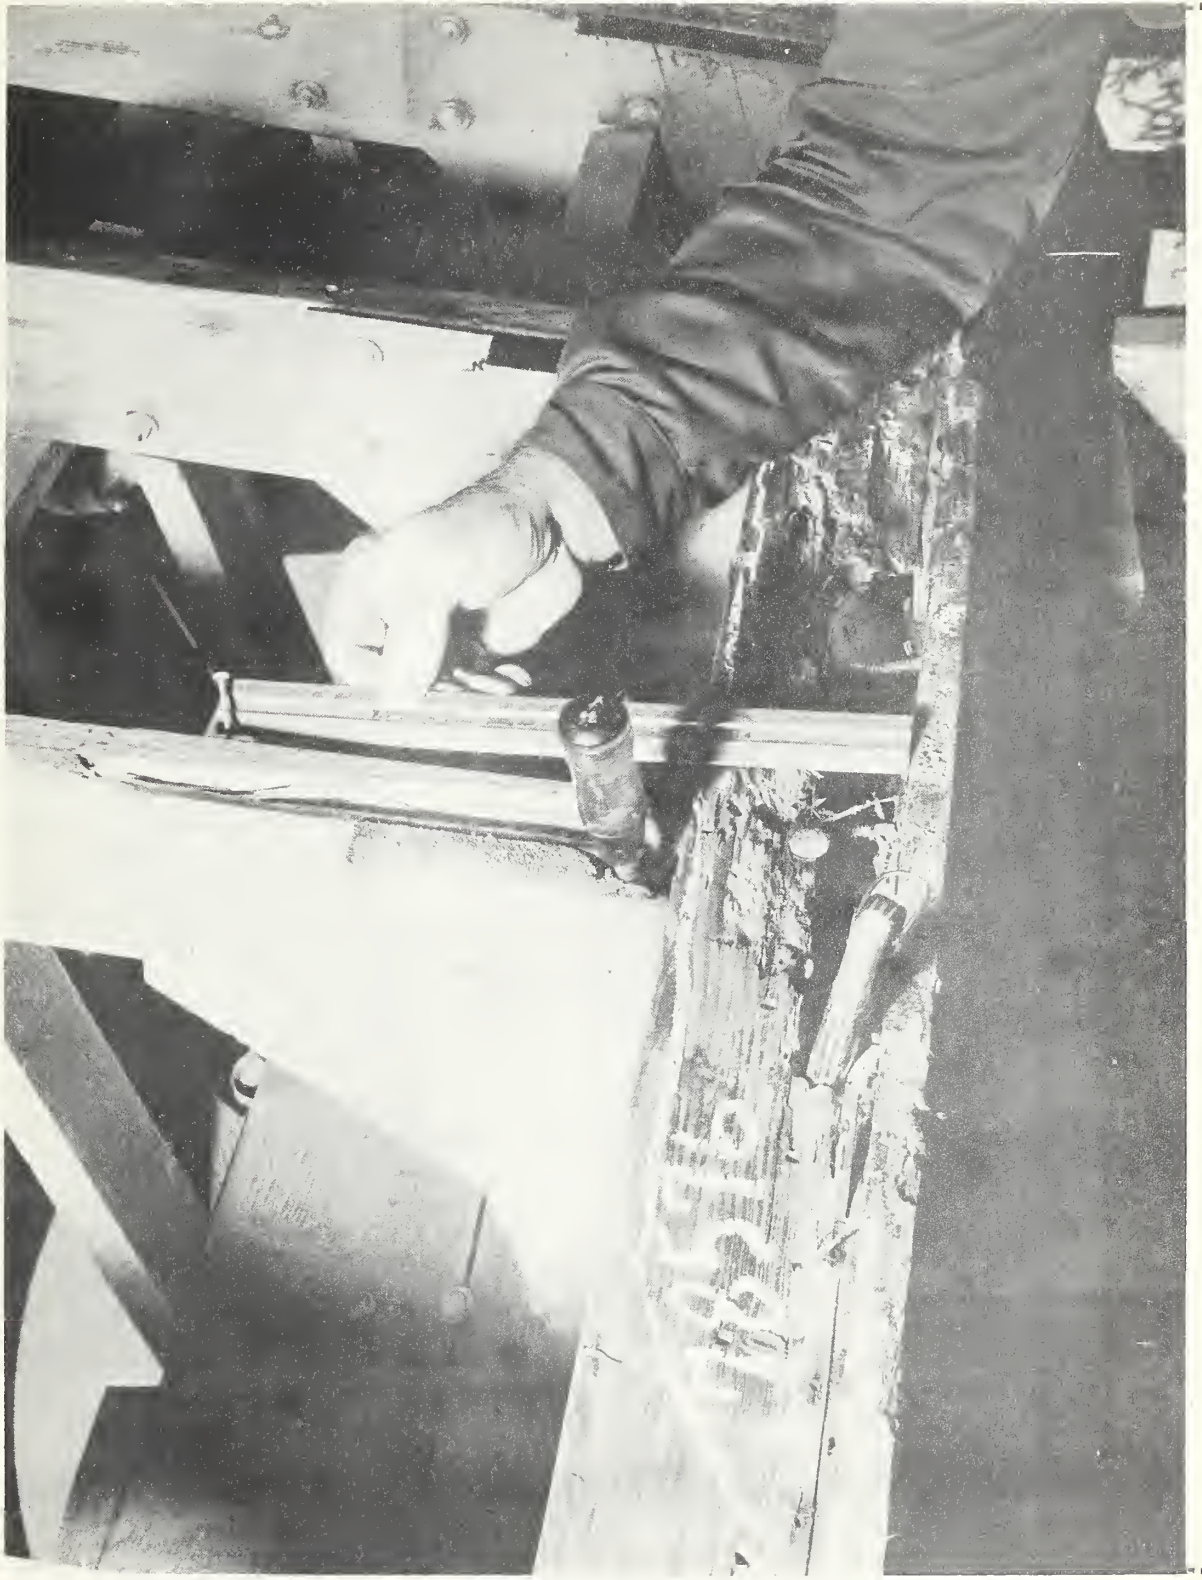
Decayed frames (Figs. 5, 6, 10) were detected in 23% of the motor launches, 20% of the landing craft, and only 10% of the motor whale boats, but the average number of decayed frames per infected boat was 10, 7, and 7 respectively for the three types. The large differences between boats indicated by these figures reflect in part real differences, but are due in part to the fact that many of the boats were not opened up sufficiently for thorough examination. That there are nevertheless real and unexplainable differences between similar boats, is illustrated by two 20-foot motor boats seen on the same inactive ship, built by the same contractor at the same time, with consecutive hull numbers and equal proportions of red oak; one of these boats appeared entirely sound and the other was severely decayed throughout. The distribution of the decay fungus is shown in more detail in the following tabulation.

Fig. 5. Decay in chine and frame of LCVP revealed only by stripping off plywood hull planking.

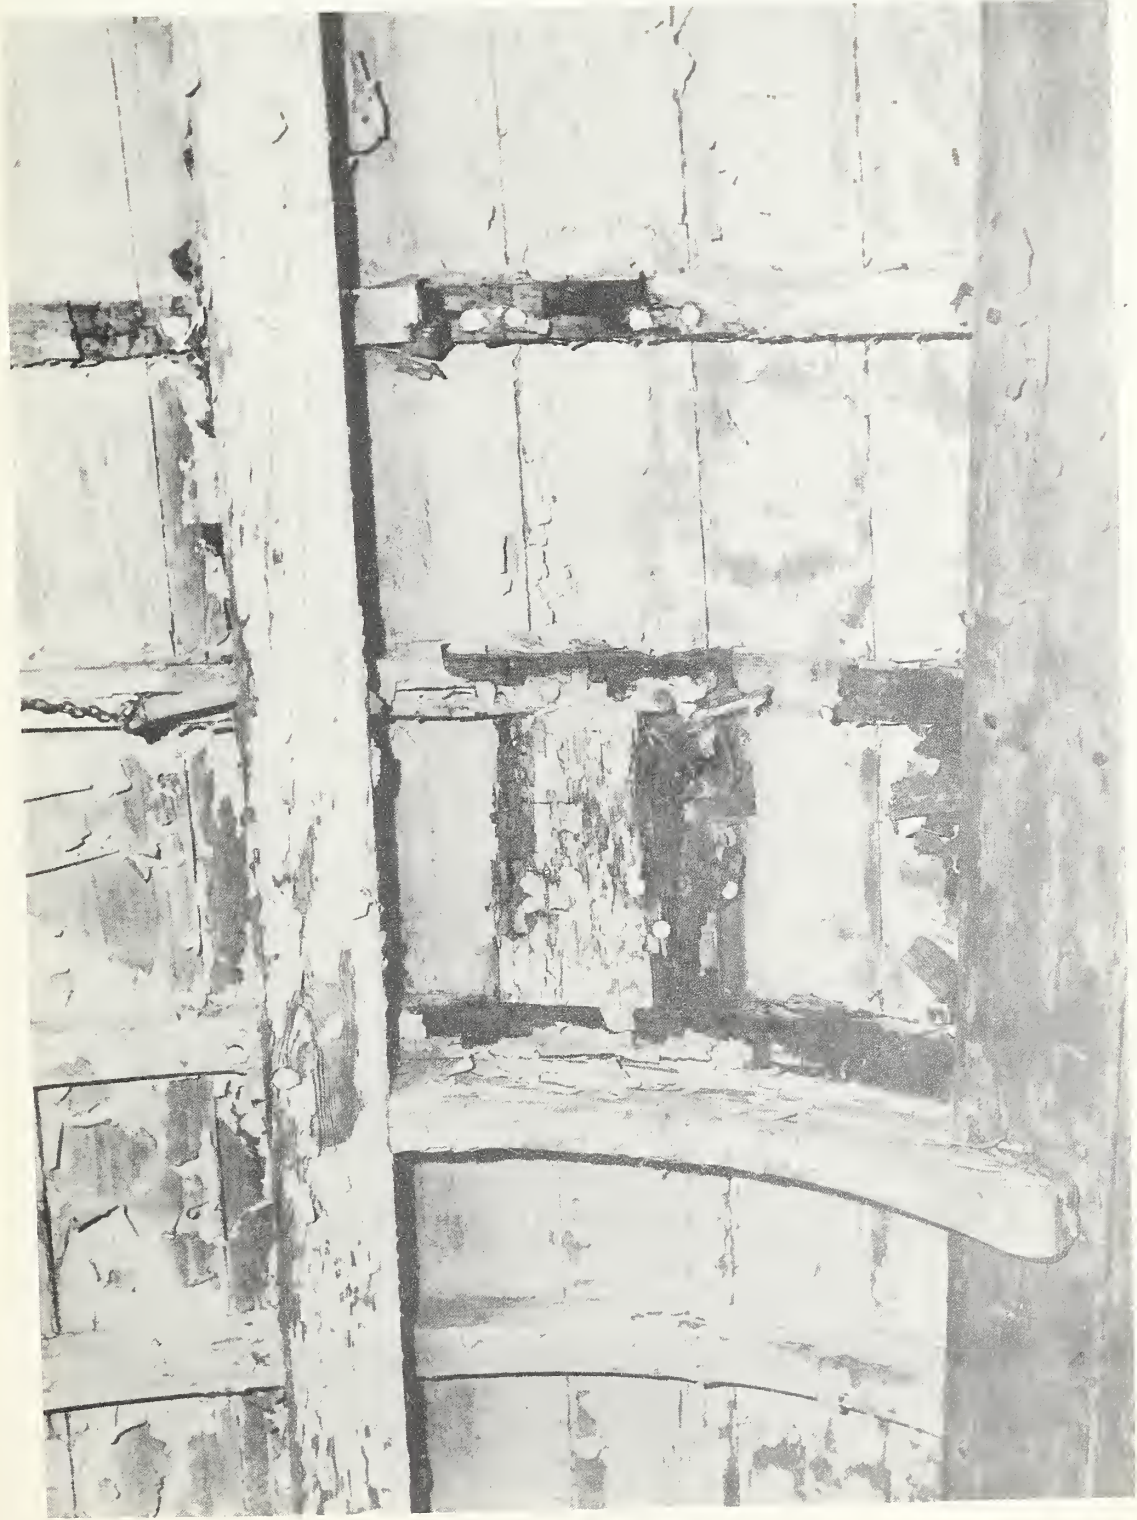
Fig. 6. Decay in 40-foot motor launch in open storage. The right and middle frames are red oak, the left frame and butt block white oak.

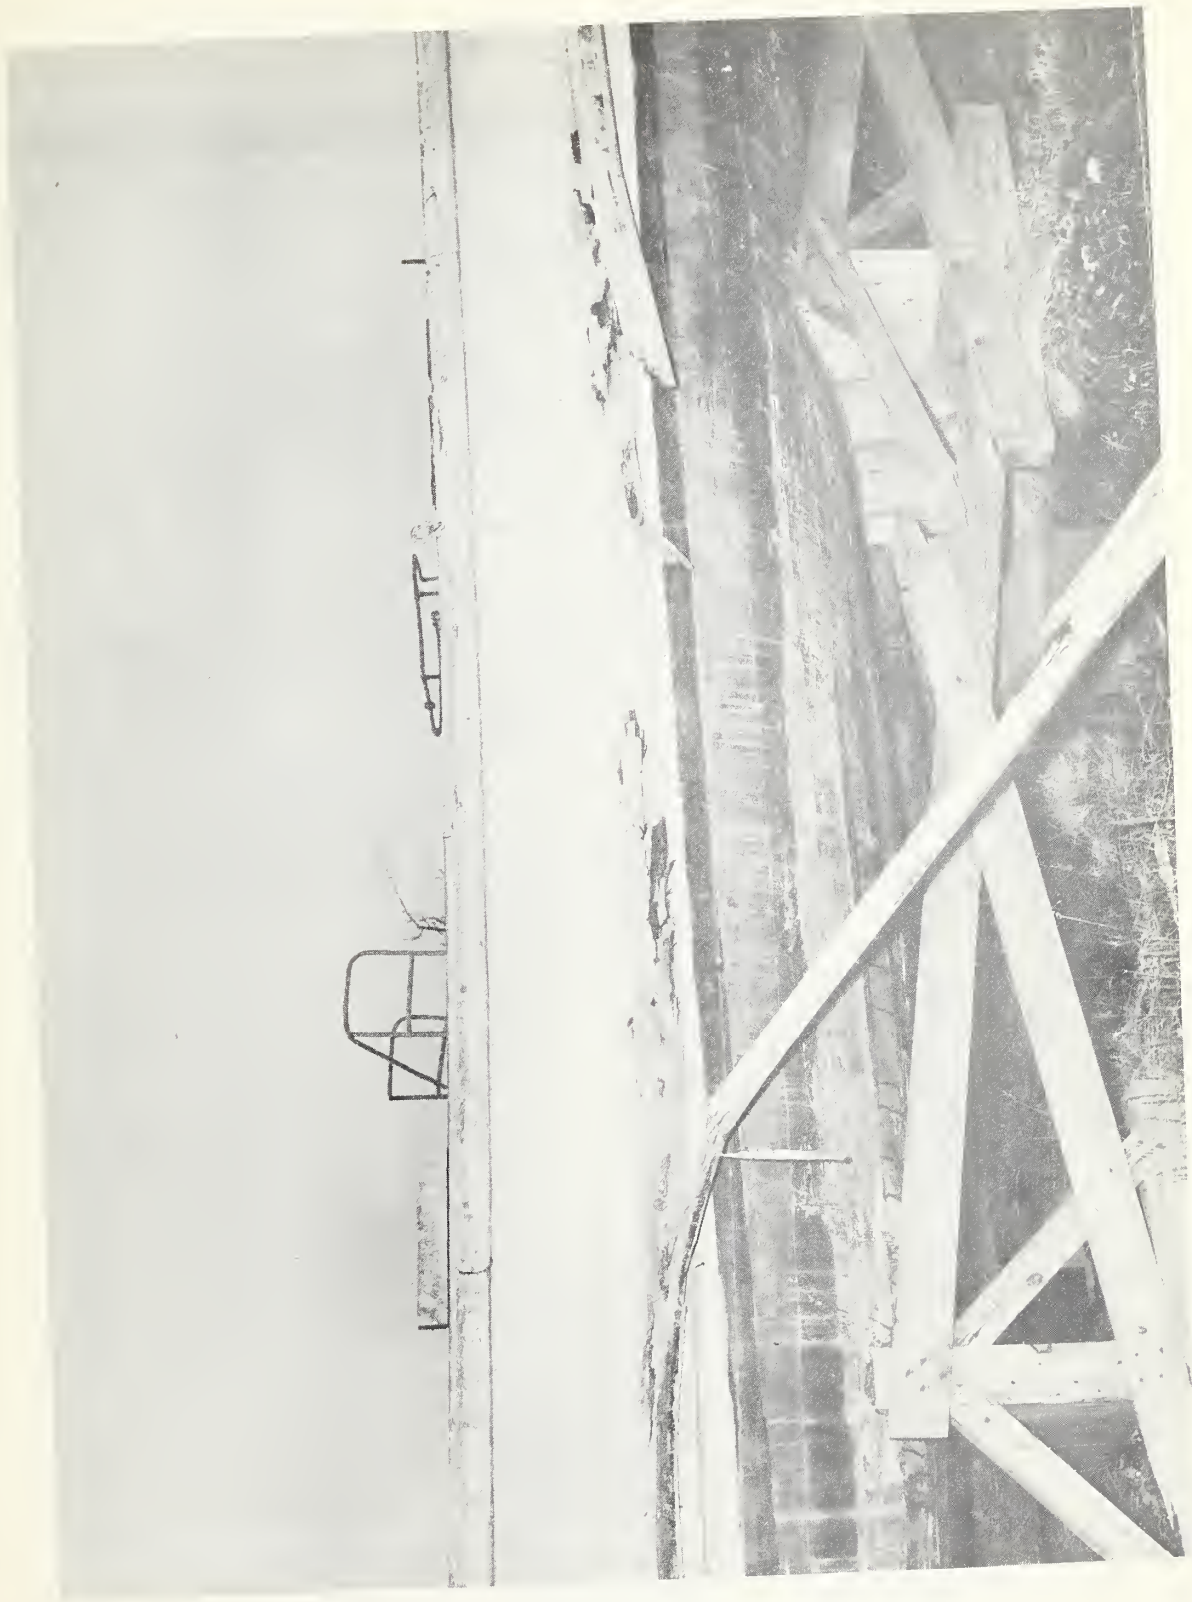
Decay in fenders was frequent but of less structural importance and relatively easy to detect. Plank under the fenders are frequently decayed (Fig. 7). Decay of keel assemblies such as appears in Fig. 10 is fortunately rare.

The most conspicuous decay resulting from use of non-durable wood has been in ash as used in thwarts, thwart knees, forepeak decks, seat boards and fenders (Fig. 7). Replacement of decayed ash, birch and maple with the same kind of wood without preservative impregnations invites repeated decay failure.

Fig. 7. Decay in bilge fender and plank under it. Rain water is trapped between them, and also between the inboard face of this plank and the riser filler blocks.

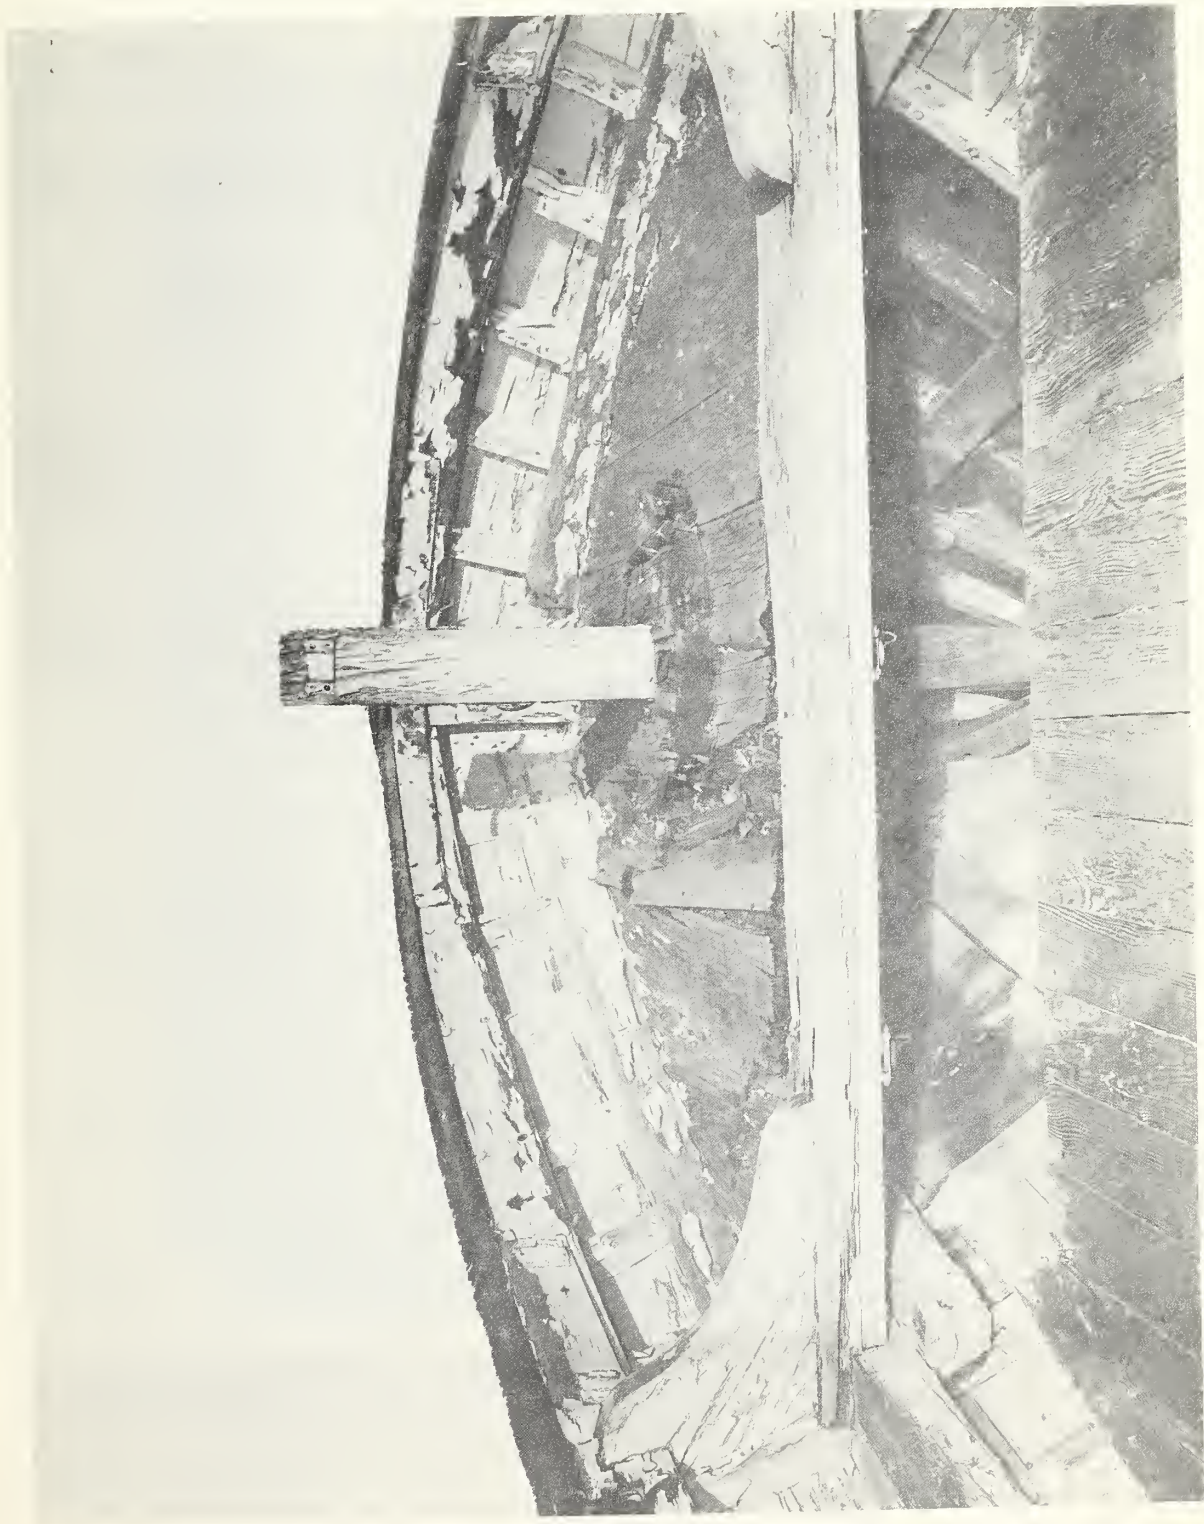
Fig. 8. Decay of ash in plank, thwart and thwart knees of motor launch in which most of the oak was sound.

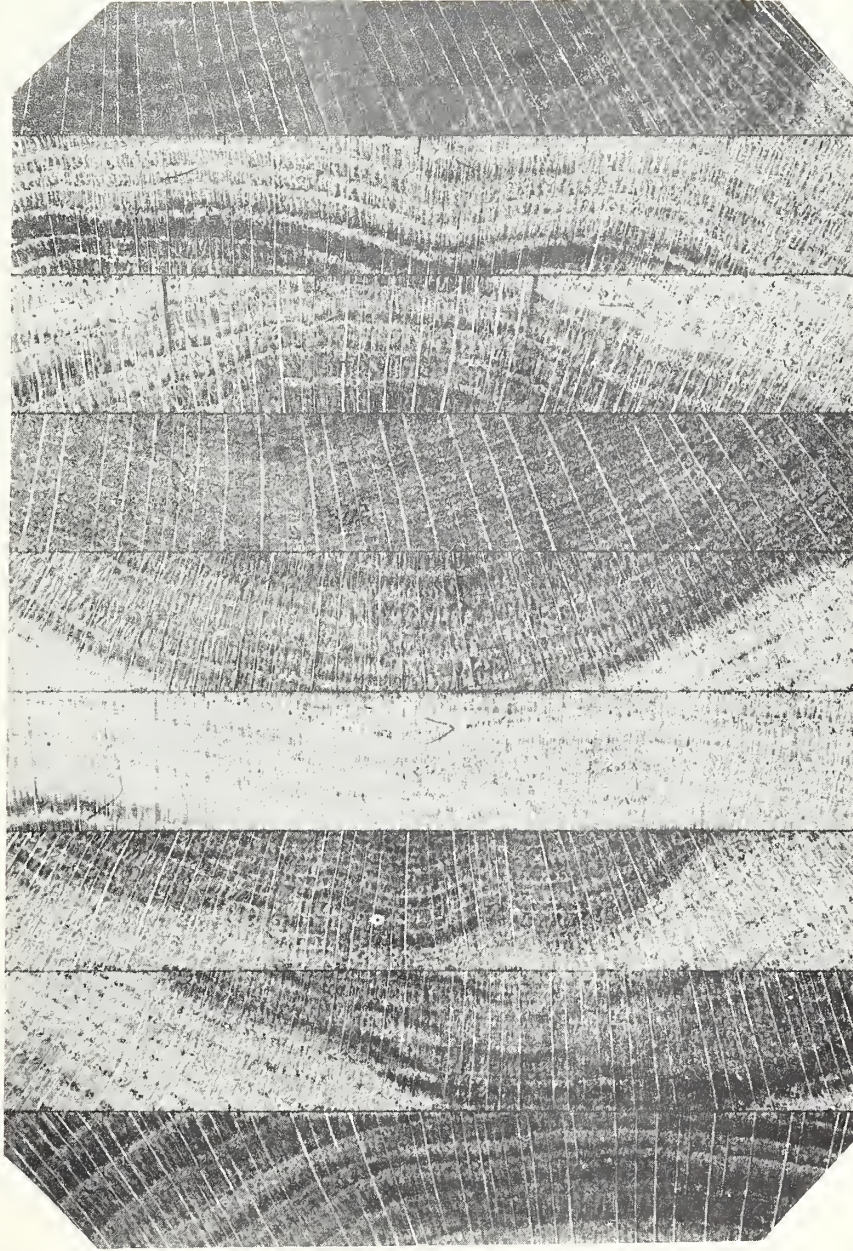
The frame shown in Fig. 9 is indication of insufficient inspection. However, a board can be within the 33% area limitation and still have sapwood across the entire width of the face at some one point. It would be safer to return to the original limit of the specification of 25% maximum sapwood area on any face, or perhaps better to make the 33% maximum apply to sapwood width at its widest point instead of the area of the whole piece. While there appears to be some difference between different laminators in the amount of sapwood they use, all of those whose products was adequately sampled had too many boards that were largely sapwood. The acceptance of all-sap boards might be lessened by providing inspectors with 0.1% methyl orange solution by which oak sapwood can be easily detected in doubtful. The methyl

Fig. 9. Top of laminated oak frame, showing sapwood making up 35% of the cross sectional area.

orange has been found (ref. 1) to serve the same purpose as the less easily procured benzo yellow previously recommended (refs. a, t). The color reaction on the oak is the same (sapwood yellow and heartwood red).

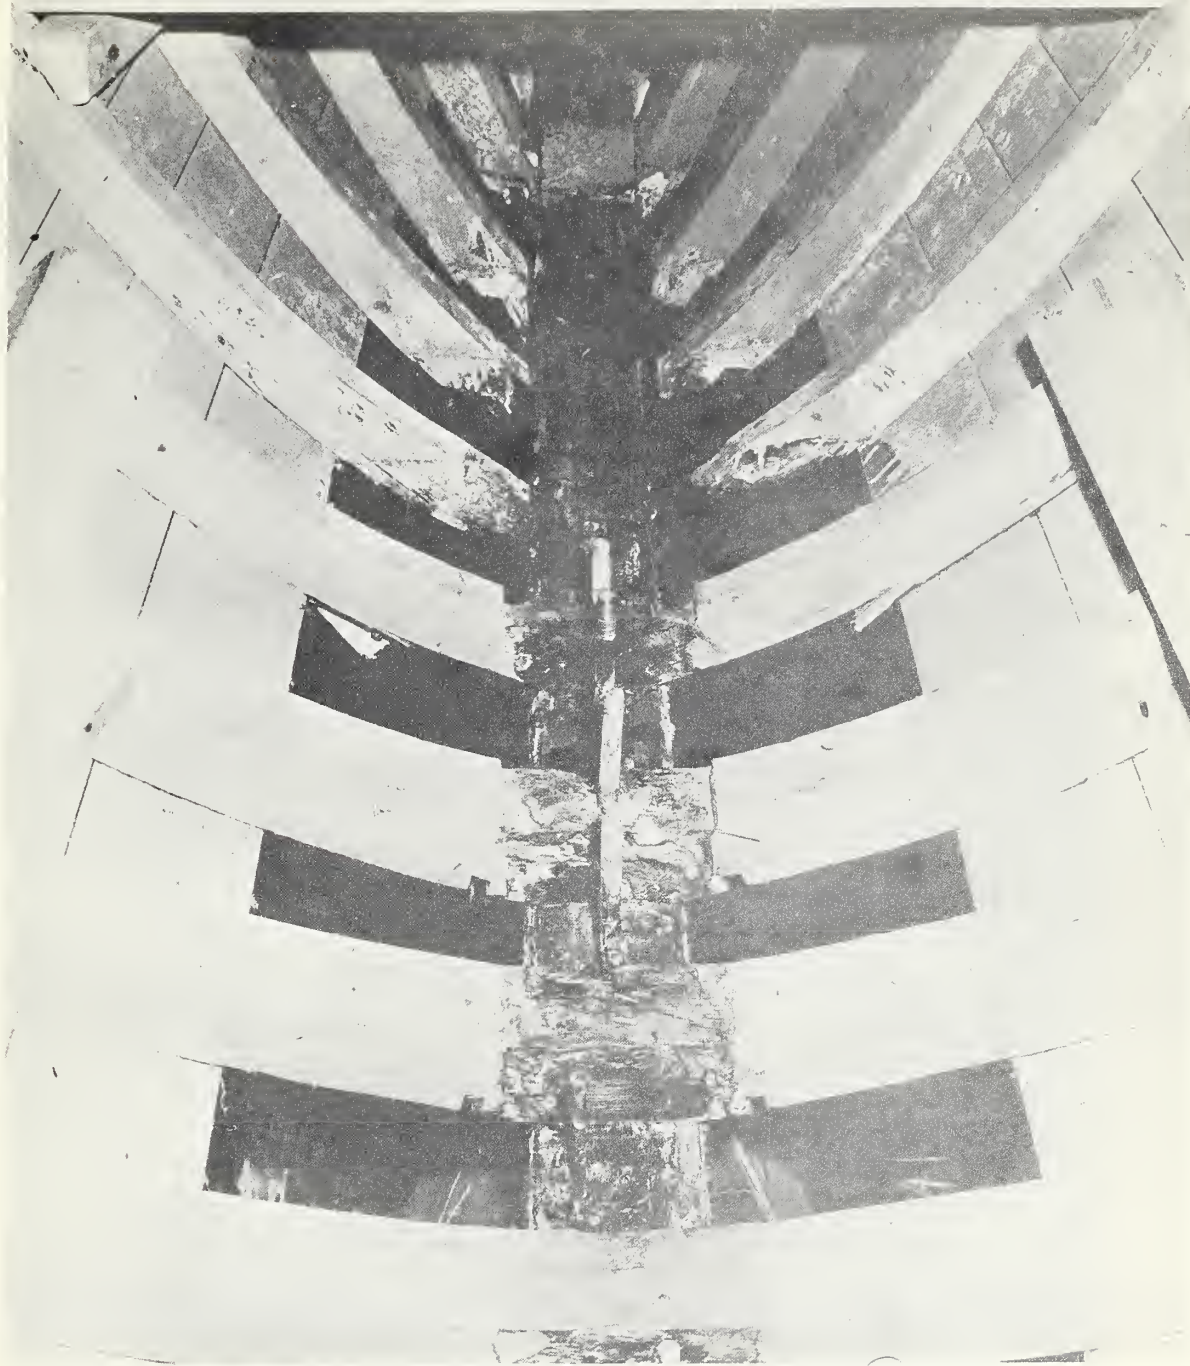
Fig. 10. Boat kept in uncovered storage. Decay apparently entered frames from infected keel assembly.

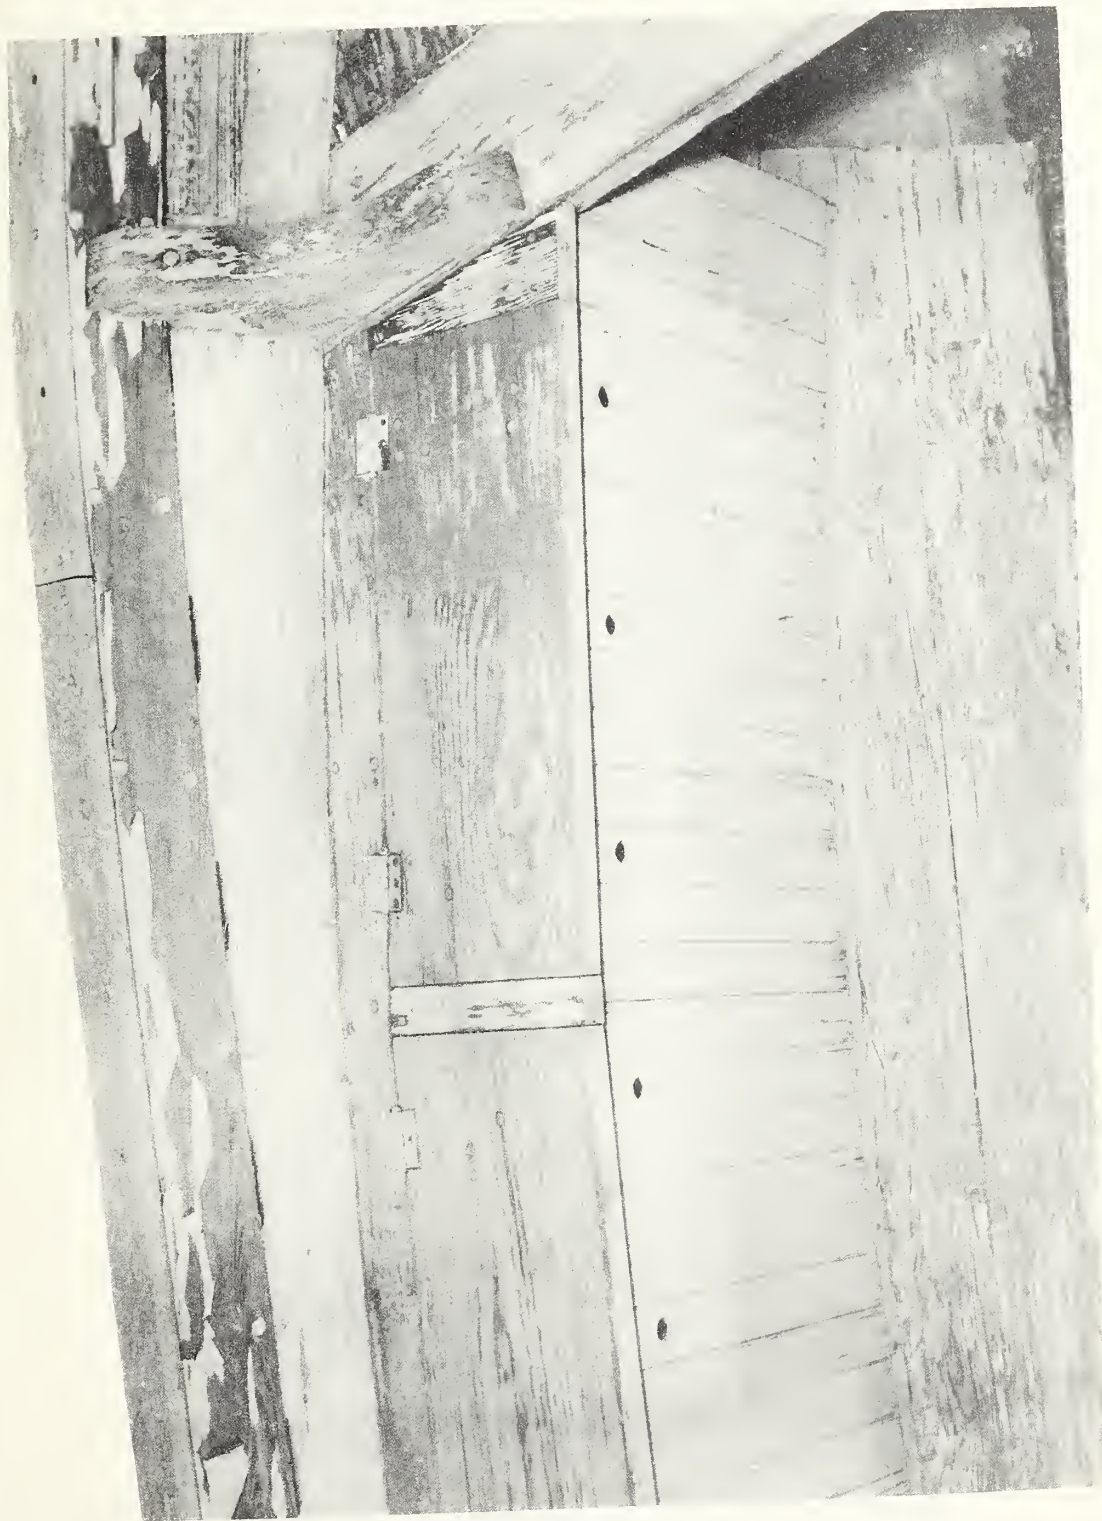
Fig. 12. Interior of Motor Launch 220013 after uncovered storage in Norfolk Naval Shipyard Test 577.
Compare with Fig. 11.
